Water logged wood and wooden foundations

Dr. René Klaassen

October 17th and 18th 2011
Workshops Estonia

water logged wood and foundation piles

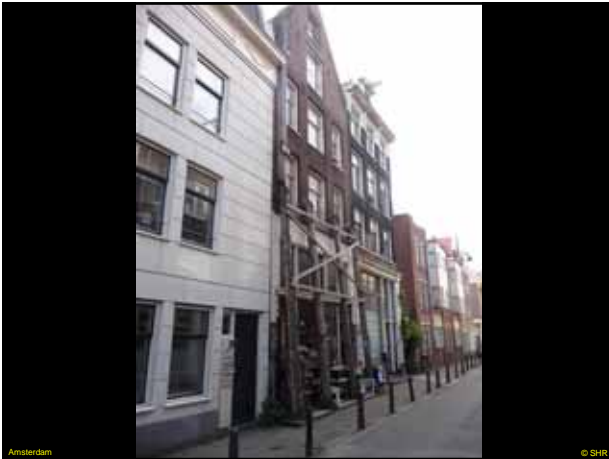
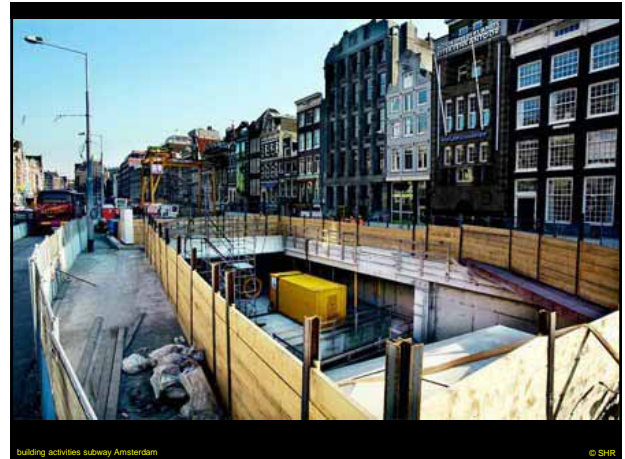
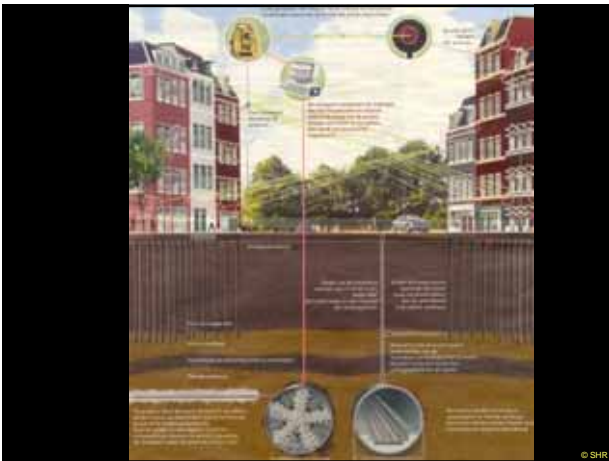
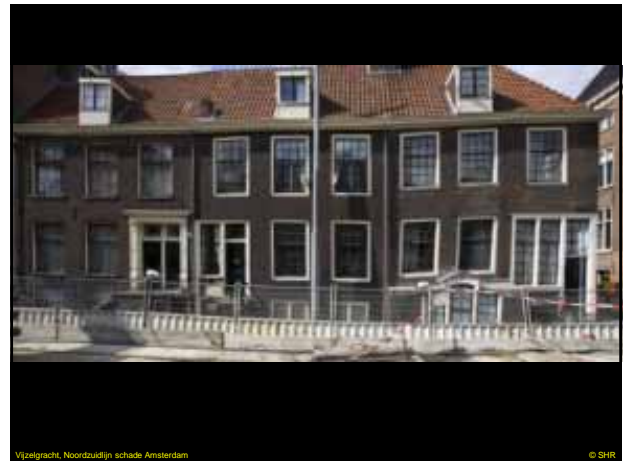
SHR **25 million piles, tekst**

It is estimate that in the Netherlands still 25 million piles are in service. Not taken in to account are construction younger than 1980. In the three decades annually app. 200.000 piles are used for founding sewage systems, enlargements of standing houses, greenhouses and special projects like founding trees, dics and even roads.

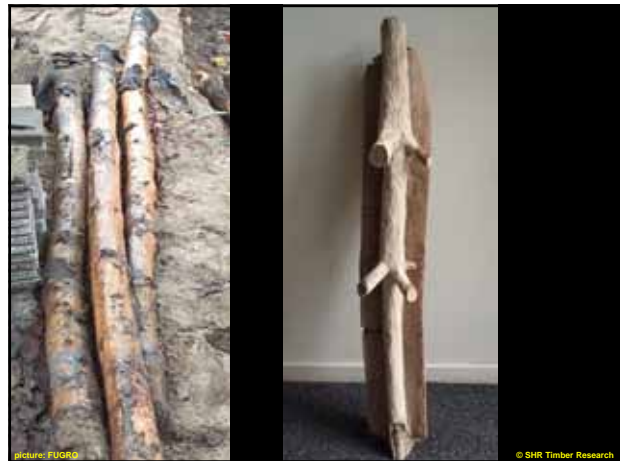
Problems, text

The fourth cause is related to bacterial decay, decay under water. All piles driving into the ground will be invaded by bacteria. This process stops in many piles after several years, however in other piles it can continue for many years a cause severe problems in time like this 100 years old piles which look sound, but have an soft peel over their whole length. This soft peel can vary in thickness from less than one mm to several cm's.

Here the soft peel of pine piles was scratched off with a knife and you can say that houses in Haarlem are not standing on wooden foundation piles of 12 cm in diameter but are actually standing on broom stick alike piles.
