## Ruhnu, July 2011

## Repair & Replacement

## Aim

To find resistant wood that can be  
used for repairs & replacements

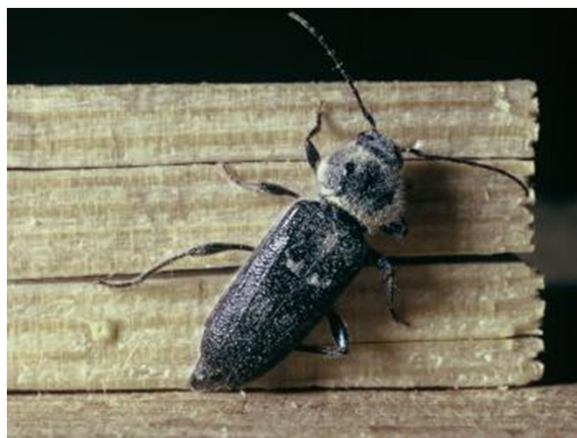
**Hylotrupes bajulus**  
Very common on Ruhnu

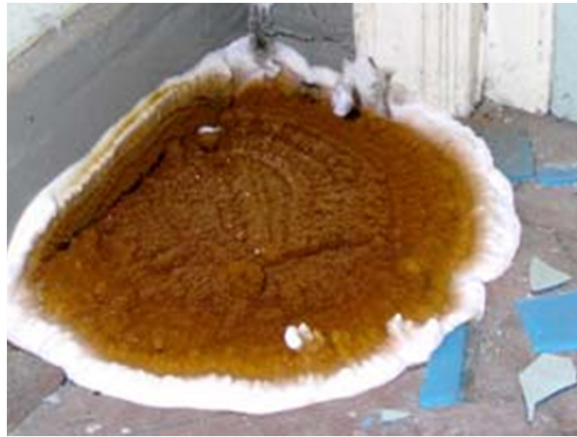
**Dry rot fungus**  
**Not much of fungal attack**

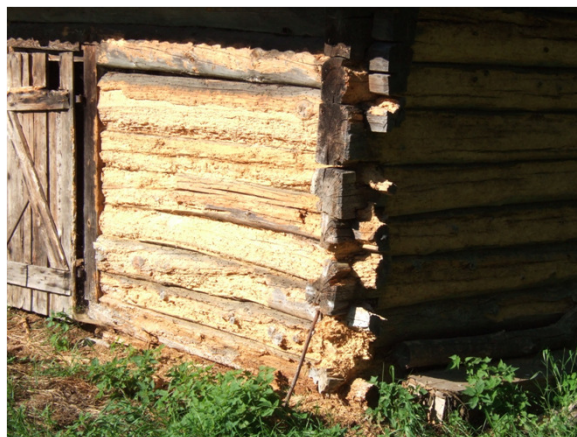
**Corner of a barn**  
**Very heavy attack by *Hylotrupes***

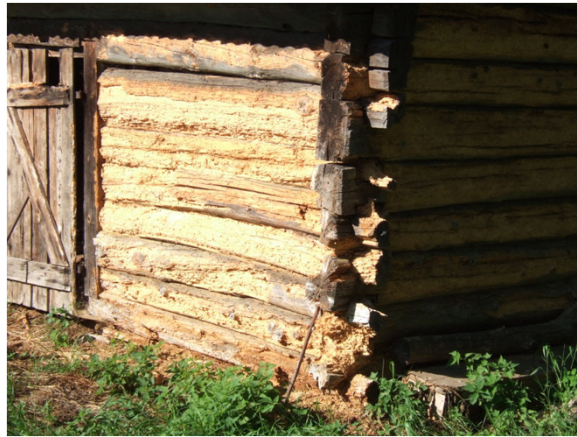
**Timber building**  
Attached to outside?

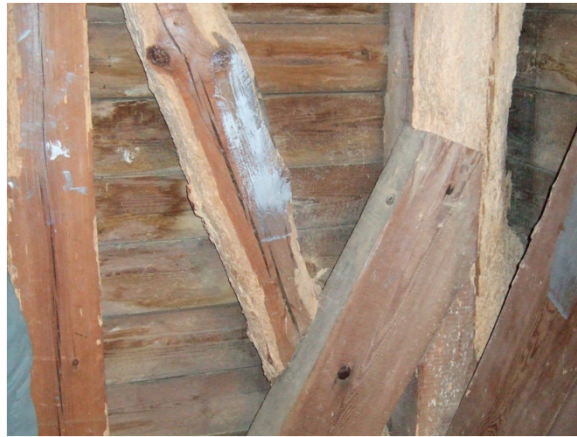
**Severe attack in new church tower**  
Strength reductions
